LaserJet / LJ2000 Troubleshooting Guide

Classic Printers

Volume 1
April 1995
Revision 13

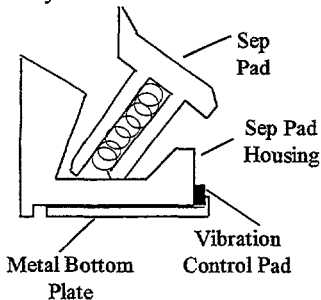
"MOANING" NOISE" in the vicinity of the Paper Pick-up assy

1. New Separation Pad available (P/N RG1-1912-080CN).
2. Try different paper, Xerox 80 paper (Black reams) is known to work well in these printers. Please note HP does not recommend paper, it's the customer's responsibility to test for a suitable paper.
3. Smoother papers can cause problem.
