LaserJet / LJ2000 Troubleshooting Guide

Classic Printers

Volume 1
April 1995
Revision 13

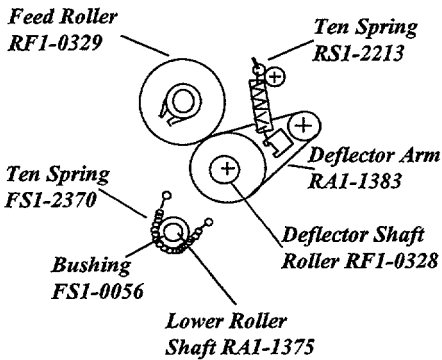
Friction Drive

1. Serial Number < 2913J02862.
2. Deflector Roller RF1-0328-040CN (Page 8b-22 item 64) has black tyres on its rollers.
3. Look at all rollers in switchback, you will observe that many are NOT directly driven gears. Instead, they friction driven from a directly driven roller.
4. As viewed from Front of Printer:

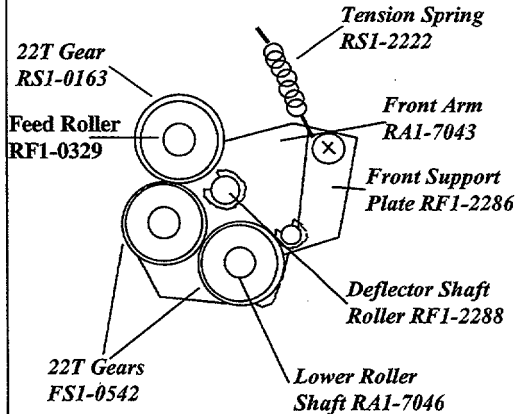
Positive Drive

1. Serial Number => 2913J02862.
2. Deflector roller RF1-2288-000CN has solid rollers, a white plastic material
3. You will note here that ALL rollers are driven and none rely on friction at all. (view end of switchback rollers from front) (of printer, with switchback covers off)
4. As viewed from Front of Printer:

Note: The Deflector Shaft is easily identifiable by means of the 9 white Triangular Deflectors on its shaft, see Fig 8b-10 in Service Manual. Paper from the fuser first enters this area in the Switchback.
